**LIFE PREDICTION OF TURBINE BLADE NICKEL BASE SUPERALLOY 1/1**

AFWAL-TR-86-4045

LIFE PREDICTION OF TURBINE BLADE NICKEL  
BASE SUPERALLOY SINGLE CRYSTALS

Final Report for Period 1 October 1983 - 31 March 1984

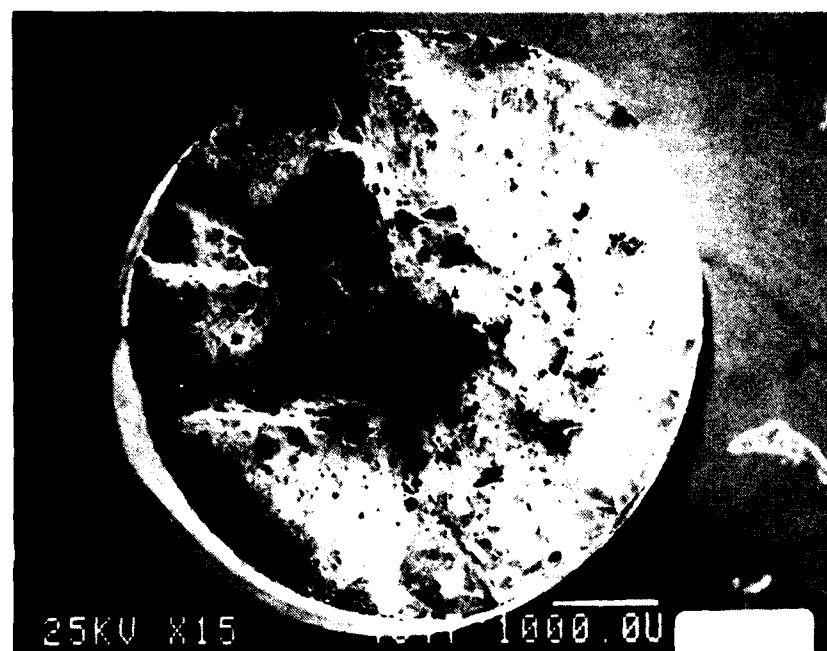
FIGURE 12 Fracture Surfaces

11. Fracture Surfaces of Bare L 151 - 1, $\Delta\epsilon_t = 0.6\%$ , $N_f = 4,956$ cy. Continuous Cycling at 1093°C (2000°F)	39
12. Fracture Surfaces of Bare E 151 - 2, $\Delta\epsilon_t = 0.6\%$ , $N_f = 1,755$ cy. Test with a 2 min. Hold in Compression at 1093°C (2000°F)	40

(E 151 - 2) which failed in 1755 cycles (3597.8 min.). Figures 12b, 13a and 13b elaborate the features seen near a few nucleation sites. Fine oxide particles are seen on the high temperature fracture areas. The fracture surfaces of the Codep coated sample (L 151 - 4 - C1) are shown in Figures 14a and 14b. The LCF life of this sample at  $\Delta\epsilon_t = 0.6\%$  is 1708 cycles (3501.4 min.) under 2 min. hold in compression. The above sample differs from E 151 - 2 only in the surface conditions; while L 151 - 4 - C1 had Codep coating, E 151 - 2 was bare. Oxide particles are seen on the fracture surface including the cross section of the fractured coating (Figure 14 a). The oxides away from the coating are angular (Figure 14b). The room temperature fracture regions of the sample, L 151 - 4 - C1, show microvoid coalescence (Figure 15b) in the substrate, decohesion of Codep coating and the brittle failure of coating (Figure 15a). Casting defects such as micro pores are seen on the room temperature fracture surface of this sample (Figure 15b). In the sample (K 149 - 3 - C1) tested at  $\Delta\epsilon_t = 0.45\%$  with a 2 min. compression hold, the fracture surface was characterized by flat and slant fracture regions and wedges (Figure 16a). A typical effect of hold time was to cause numerous circumferential cracks along the gage length, and one such crack is shown in Figure 16b. This crack is deep and connected with the fracture surface. This sample survived 3693 cycles (7570.7 min.). The oxide morphology in this case, (Figures 17a and 17b) differs from that observed in the sample L 151 - 4 - C1, (Figure 14). The test conditions of the above samples were the same except for the strain range. In this case (K 149 - 3 - C1) oxides are more rounded and look like pebbles. When the strain range was reduced to 0.35%, the outer region of the coating fracture surface remained free from oxides, (Figure 18a; Sample

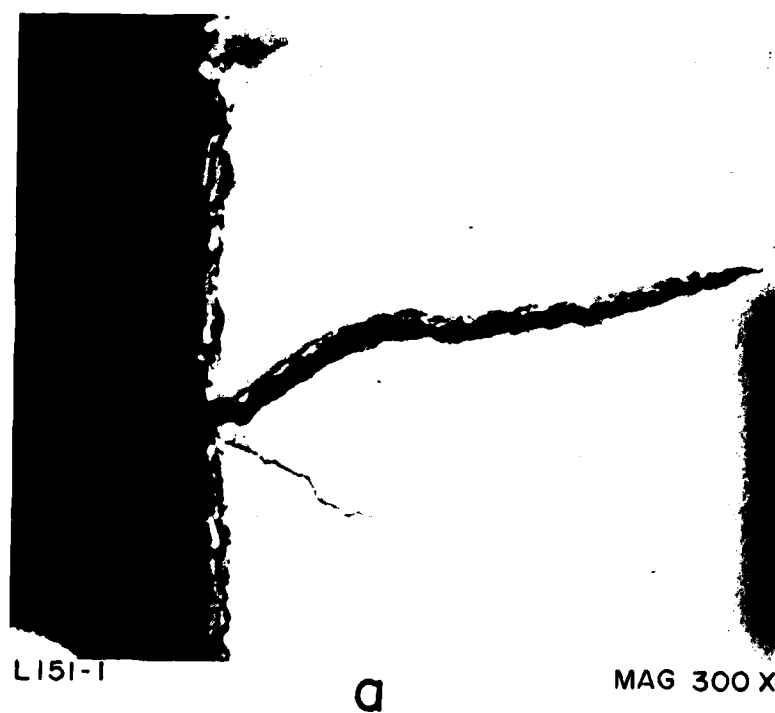
FIGURE 24 Polished and Etched - Longitudinal Sections

23. (a) Longitudinal Section of uncoated L 151 - 1 with Inclusions, (b) EDAX Spectrum of an Inclusion	51
24. Longitudinal Sections of Uncoated L 151 - 1 with Transverse Cracks originating from the Free Surface. Continuous Cycling at $\Delta\epsilon_t = 0.6\%$ , $N_f = 4,965$ cy, $T = 1093^\circ\text{C}$ ( $2000^\circ\text{F}$ )	52

Several transverse cracks have nucleated during the LCF test with  $\Delta\epsilon_t = 0.6\%$  under continuous cycling (L 151 - 1). Figure 24a shows two such cracks originated at points close to each other on the surface. They are diverging, and one of them is dominant. A short crack appears to have nucleated at the surface in an oxidized inclusion (Figure 24b). Secondary cracks below the fracture surface of the sample E 151 - 2 are shown in Figures 25a and 25b. Some of them are connected with the fracture surface. Numerous transverse cracks with varying lengths are seen in the longitudinal sections of the sample E 151 - 2 (Figures 26a and 26b). The above sample was fatigued at  $\Delta\epsilon_t = 0.6\%$  with a 2 min. hold in compression.
